Table of Contents

Why the need for advanced diagnostics?

Due to the increased complexity of these cabling systems, determining the cause of failure and quickly restoring suitable performance has become a challenging task. This handbook guides you through the troubleshooting of advanced structured cabling systems using the Fluke Networks DTX Series CableAnalyzer™ so you can increase your productivity and deliver better value to your organization.

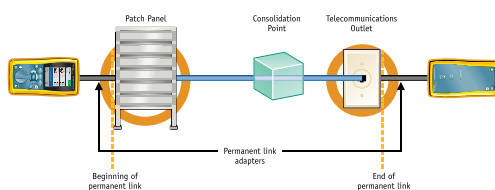
Figure 1: Permanent Link Model

The Permanent Link test model requires that the test-interface cables connecting the test tool to the link-under-test are totally transparent to the measurements. In a practical sense, this means that certification test tools must be much more sophisticated to subtract the test cord effects/contributions for each test parameter measurement.

However, the Permanent Link model includes the performance of the end connections – the mated connection of the 8-pin modular plugs (RJ45) at the end of the test adapters and the jacks (sockets) of the link. Plug-jack combinations can deliver varying test results for critical parameters like Near-End Crosstalk (NEXT) and Return Loss. To properly assess the performance of the end jacks of the link (in the TO and the patch panel) and the wire pair terminations in those jacks, the plug at the end of the Permanent Link test adapter shall be a test-reference plug. A test-reference plug delivers, for all frequency-sensitive test parameters, performance in the center of the component specifications within a narrow band of tolerance. These plugs do not vary much one from the other and deliver repeatable test results.

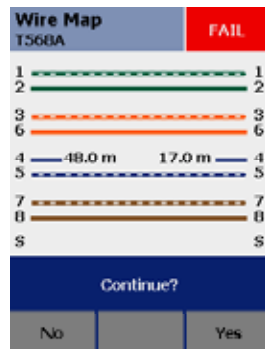
Figure 3: The wire connecting pin 4 is open at 48 m from the main unit and at 17 m of the Smart Remote unit.

If the cabling link fails to pass the wire map test – the test that verifies that all 8 wires connect the right pins at either end of the cable – the tester halts the test and displays the results. Figure 3 shows such a wire map failure. The wire in pair 1 that connects pin 4 is open at 48 m from the Main units and at 17 m from the Smart Remote unit. The DTX Main unit is represented as the left-hand side of these screens. The software halts and asks the operator whether or not to continue the test. It often makes more sense to tackle the wire map error before continuing the test. The open wire causes the results for some test parameters to be undefined. For example, the insertion loss of the wire pair that is open is infinite. Any parameter based on a calculation with the insertion loss value is therefore invalid or undefined.

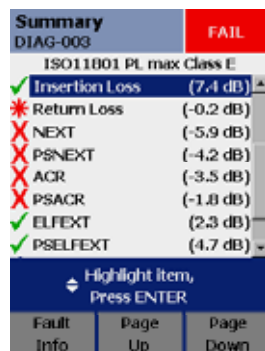
Figure 4: Upon completion of an Autotest, the tester’s screen shows the list of test parameters executed for the selected test standard. Test parameters marked with the red X fail. The tester also displays the worst-case margin for each parameter in parentheses at the right edge of the screen.

Figure 4 shows the test result screen of a failing Class E link. Return Loss shows a marginal failure whereas Near End Crosstalk (NEXT), Power Sum NEXT (PSNEXT), Attenuation-to-Crosstalk Ratio (ACR) and Power Sum ACR (PSACR) show outright failures. The numbers in parentheses on the right hand side of the screen show the worst-case margin for the corresponding test parameter.

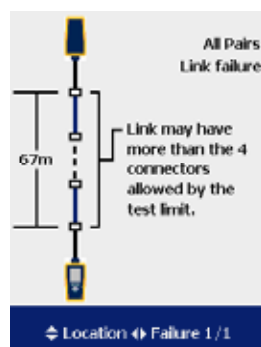
Figure 5a: All of the automatically generated diagnostics graphically show the link with the main unit at the bottom of the picture and the Smart Remote on top. The diagnostics show a link of 67 m with four connections and some uncertainty in the center (dashed line). The diagnostics suspects that the permanent link may have too many connections.

In figure 5a, the tester entertains that the link may have more than four connectors. A first possibility for the failures after analyzing the test results data. The link in question contains four connectors as the tester screen shows. So this diagnostic does not apply.

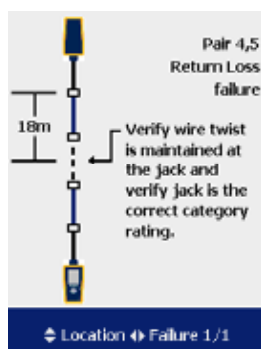
Figure 5b: Press the up or down arrows to move from one suspect location in the link to the next. Move the right/left arrow keys to read multiple diagnostics at a location. This location at 18 m from the Smart remote only shows one defect that is expected to be the cause of the marginal return loss results for wire pair 4,5. The tester also posts the recommended inspections and corrections.

In figure 5b, the diagnostics show that a shorter cable segment at 18 m from the remote unit contains a Return Loss defect that causes the marginal result for wire pair 4,5. The tester prints the recommended inspection: "Verify wire twist is maintained at the jack and verify that the jack is the correct category rating." In other words, either the wire termination at the jack or the jack itself is the source of the marginal test result for RL on pair 4,5.

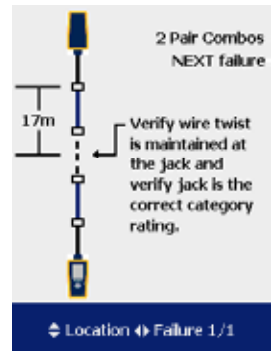
Figure 5c: This screen places the source of the NEXT failures in two of the wire pair combinations at 17 m from the Smart Remote unit. The text in the screen provides the suggested inspections and corrective actions.

Figure 5c shows the next possible fault location identified by the tester diagnostics. At approximately 17 m from the remote tester unit, excessive crosstalk occurs between two wire pair combinations.

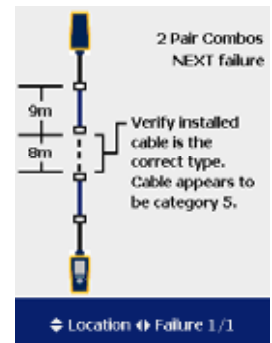
Figure 5d: The last diagnostic suspects the cable between the two middle connections. You learn in this text that the real cause of the link failures is the untwist of the wires at the end of the patch cord.

A last possibility is shown in the screen of figure 5d. The tester locates a connector at 9 m from the tester remote unit and an 8 m cord to the next connector in the link and suspects the cable in the segment between these connectors. The message "Verify the cable is the correct type. Cable appears to be category 5." warns that the source of the failure could be that the 8-meter cord is a Cat 5 cable in a link in which all component should rate as Cat 6 in order to obtain Class E performance. Note that this screen tells us that the second connector at the end of the patch cord is 17 m removed from the tester remote unit. So, which one of these automatically generated diagnostics is correct?

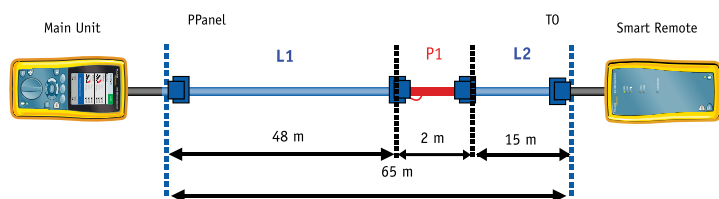
Figure 6: The map of the permanent link under test. The wire pairs of patch cord 1 are untwisted at the left termination as indicated in the schematic diagram.

Figure 6 shows the configuration of the link we constructed for this test.

Note that the configuration of this test link is unusual. The recommended Permanent Link configuration ends in a patch panel on one end and the TO at the other end with optionally a consolidation point (CP) (connection) no less than 15 m from either end, as depicted in figure 1. In this regard, the diagnostic depicted in figure 5a is also correct. This Permanent Link contains one more connection than usual or than recommended. We know, however, that after replacing the defective patch cord with a good one, this link, including the connector, normally meets the Class E permanent link test.

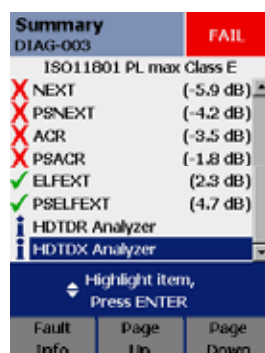
Figure 8: Access HDTDX and HDTDR data by selecting the parameters. They are shown at the end of the list of test parameters. They are not test parameters as defined by the standards. The 'i' symbol before their names indicates "for information only."

When an Autotest yields a Fail result and the diagnostics in the tester generate the time domain data, the detailed diagnostic information is captured in the HDTDX and HDTDR test parameters. The tester software further analyzes this time domain information to generate the graphical results with recommendations for the corrective action as we discussed earlier. The user can view the HDTDR and HDTDX information. Figure 8 shows the two diagnostic parameters on the tester's screen. Highlight HDTDX and press ENTER to see the screen depicted in Figure 9. This figure shows the magnitude of the NEXT coupling along the link for all six

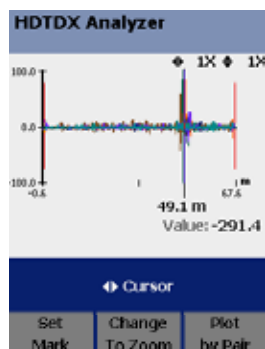
Figure 9: The HDTDX trace depicts the amount of crosstalk that is generated at each location along the link. The horizontal axis is labeled in meters or feet (not MHz!). The Main unit is always located at the left of the screen and the distances are measured from the Main unit. The spike at 49.1 meters from the Main unit shows the location with an exceptionally high amount of crosstalk.

wire-pair combinations. First, note that the horizontal axis runs from 0.6 m to 67.6 m or shows the length of the cabling link-under-test. The link starts at 0 m and runs through 67 m. The very ends (0.6 m) of the trace show the permanent link adapters, which do not belong to the tested permanent link. This is the same link we discussed earlier and that is depicted in figure 6.

The curves show the magnitude of the NEXT coupling at each point along the link. When you inspect the curves from left to right, it is immediately clear that the NEXT coupling is relatively low until we arrive at 49.1 m. A huge spike in the NEXT curves indicates that the coupling at this point is excessive and the probable cause of the link NEXT test failure. The cursor is automatically positioned at this spike and the tester reports the distance at which the cursor is located. The tester's screen also displays the magnitude of the NEXT coupling measured at the point where the cursor is placed. The value is -291.4 and is "off the chart" indicating that a huge amount of crosstalk takes place at this location.

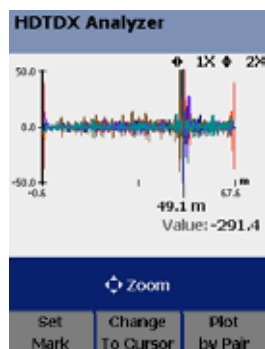
Figure 10: In order to get a better assessment of the profile of crosstalk, we have selected to zoom in on the vertical axis with a factor of two. The scale now runs from +50 to -50.

The screen in figure 10 remains very busy because it shows the NEXT profile for all wire pair combinations. For further analysis, you may elect to show the data for each pair combination; press F3, labeled 'Plot by Pair' to view each pair combination. Figure 11 shows the NEXT profile for the 1,2 – 4,5 pair combination while at the same time we have zoomed in on the horizontal axis around the main reflection located at 48.7 m. Note that this location is physically the same one as shown in figures 9 and 10 at 49.1 m. The conversion from time to distance varies a little from pair-to-pair, because the

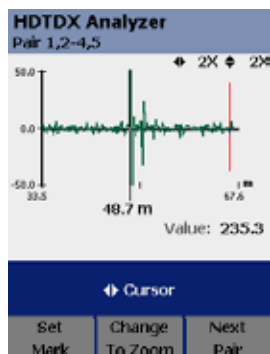
Figure 11: To further examine the HDTDX trace and determine what is happening between different wire pairs, we view the traces by wire pair combination. This screen shows the crosstalk along the link for the combination of the 1,2 and 4,5 wire pairs. Two spikes are clearly visible, the biggest one at 48.7 m. The screen also shows the value of the reflection from this location as 253.3 – a value that is clearly off the charts.

We can further analyze what is happening along the cable at the first huge NEXT spike at 48.7 m. In the cursor mode of operation, press the 'Set Mark' key (F1) with the cursor in position at 48.7 m and move the cursor to the right and align it with the second big spike. The result shown in figure 12 tells us that this second spike is located at 50.8 m and that the distance between the marker and cursor is 2.1 m.

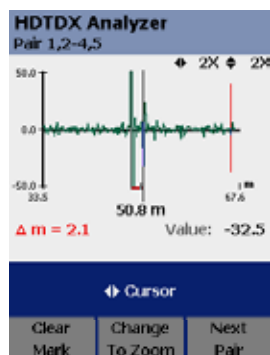
Figure 12: The traces can also be examined around peaks of interest. This screen shows that we can set the marker at the location identified in figure 11 and then move the cursor to the right. It places the second peak at 50.8 m. By comparing this information to the link map shown in figure 6, you can see that the HDTDx trace identified the two connectors of the patch cord and the one with the untwisted wire pairs causes a huge amount of crosstalk.

The two bigger spikes we have identified here show the location of the connectors at either end of the 2-meter patch cord in the link (see figure 6). No other significant spikes are shown in the graph of figure 11. Thereby we can conclude that the 2m patch cord is the source of the problem. This conclusion, of course, coincides with the conclusion we had reached using the automatic diagnostics generated by the tester. In some case, this more detailed HDTDx analysis can greatly assist in a determination between a faulty cable versus faulty connections or poor wire termination. If significant levels of NEXT are shown in a portion of the cable, removed from any connections, defects are disclosed in the cable and the remedy may be much more complicated since the cable itself may have to be replaced.

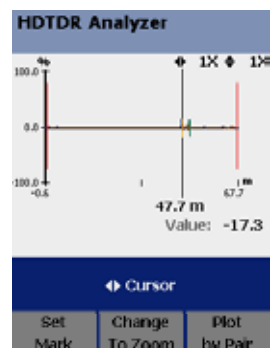
Figure 13: The HDTDR trace shows the signal reflection on each wire pair. Locations showing an excessive amount of reflected energy are the cause of return loss failures. The HDTDR traces typically show fewer and smaller reflections than the HDTDx traces.

Figure 13 shows the full-scale HDTDR plot for the channel we have been analyzing in this booklet. Without zooming in, the HDTDR trace shows few reflections except at the initial location of the cursor at 47.7 m where the measured reflection is -17.3%. The values for HDTDR will generally be smaller but the link test results are much more sensitive to small reflection values. To show a more detailed analysis, we

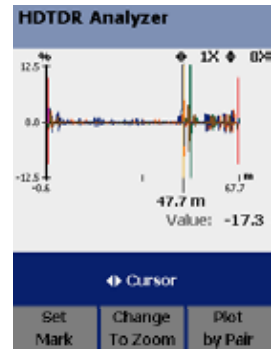
Figure 14: This figure shows the exact same data as in figure 13 but we have increased the sensitivity of the vertical scale by enlarging the vertical axis with a factor of 8. More reflections are now visible but the major one remains at the distance of 47.7 m.

have increased the zoom for the vertical axis of the same trace to 8X in figure 14. Figure 15 shows the HDTDR trace for wire pair 4,5. We have moved the cursor to the left to show the sharp peak more clearly in the trace at the location of the untwisted wire pairs. This picture clearly shows how the HDTDR trace allows us to identify a location with a significant return loss problem.

Upon closer inspection of figure 14 we can also determine that the shorter 15 m link segment (L2 in figure 6) to the right of the defective patch cord shows significantly more return loss for several wire pairs than the higher quality cabling segment to the left (L1).

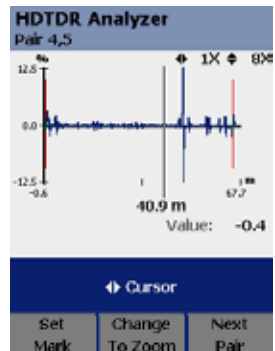
Figure 15: This figure shows the reflection for pair 4,5 only. To show the spike in the reflections more clearly, we moved the cursor a bit to the left. The more significant points of reflection toward the ends show the location of the connectors. The cable segment L2 on the right shows significant reflections in the cable itself.

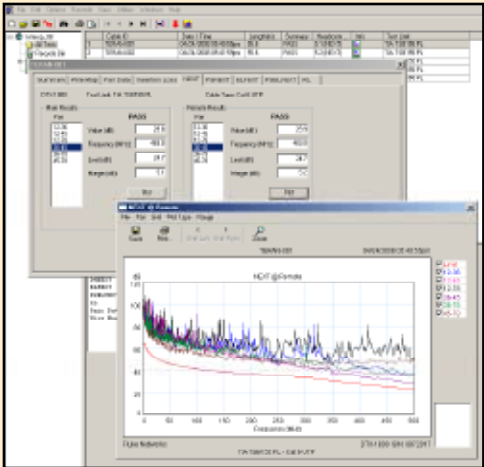
Figure 17: LinkWare allows you to manage the test results data. If you store the graphical data in the tester, you can upload this data into LinkWare. This allows the user to access the information with a few mouse clicks any time in the future. HDTDX and HDTDR data are part of the data stored in LinkWare if they have been generated as a result of the link failing. This information can be useful if the technicians in the field need assistance with the analysis of the cabling defects.
